**INVESTIGATIVE REPORT TO
JOINT COMMITTEE TO
INVESTIGATE THE I-35W
BRIDGE COLLAPSE**

MAY 2008

INVESTIGATIVE REPORT

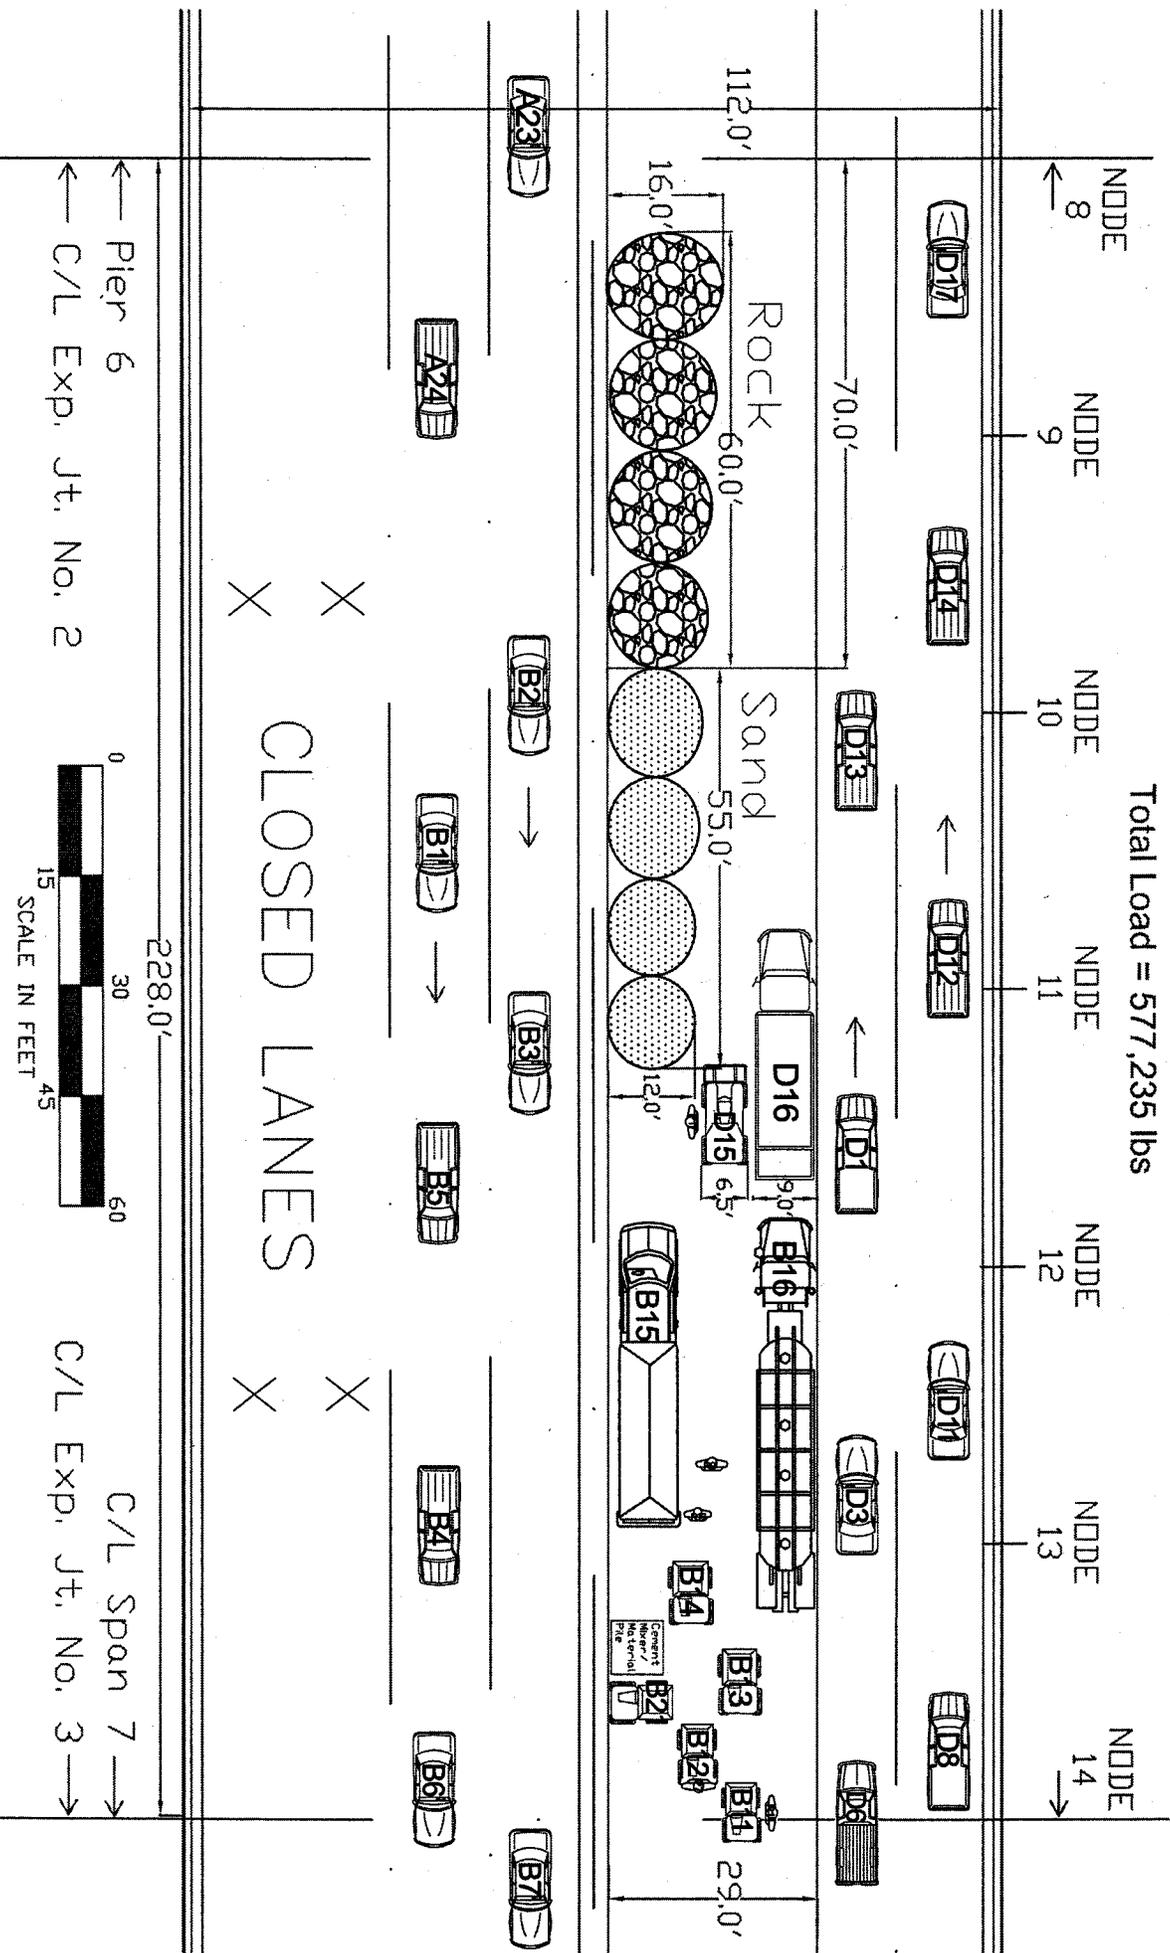
Figure 2 – Construction Staging Area

1 Skidsteer and 5 Scootretes with associated material and workers = approximately 21,655 lbs

Total Load = 577,235 lbs
