# 3M Water Infrastructure

June 22, 2015

# 3M's solution can solve multiple problems with one solution

# Case Study – Dual Application while Returning Water to Service Same Day

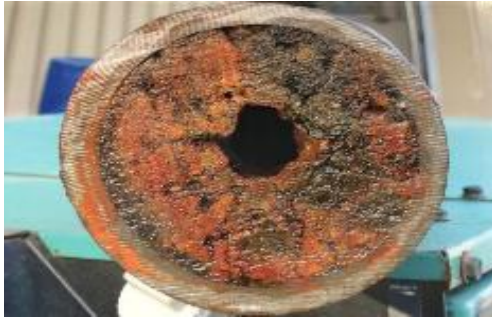
Some pipes have tuberculation, corrosion related pin-hole leaks, and brown water

**Corrosion barrier**  
Prevent tuberculation and corrosion related pin-hole leaks, and protect clean water

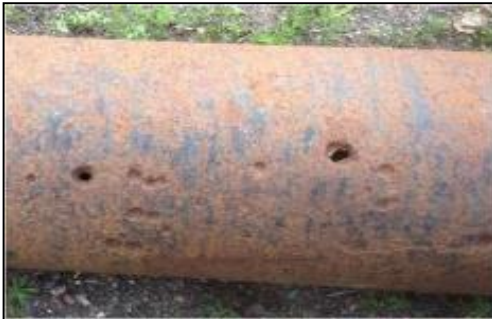
Some pipes are more deteriorated and require a structural enhancement solution

**Structural enhancement**  
Internal pressure containment that will withstand the formation of small holes or gaps

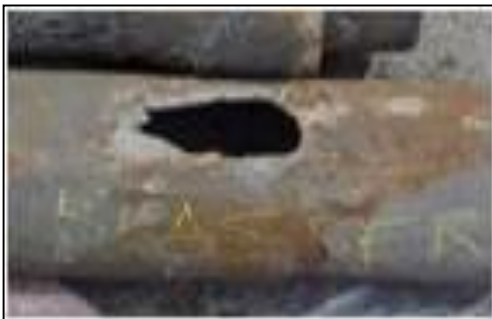
Some pipes are close to failure

**Pipe replacement**

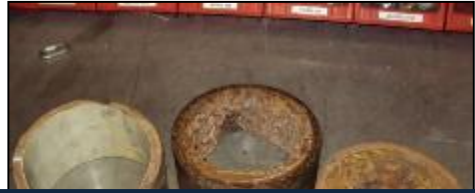
Some pipes have tuberculation, corrosion related pin-hole leaks, and brown water

Thin coating

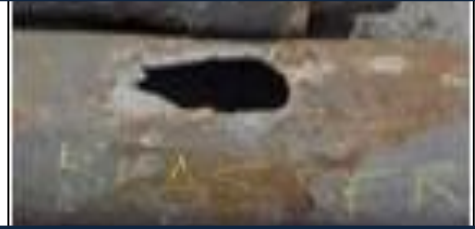
Some pipes are more deteriorated and require a structural enhancement solution

Thick coating

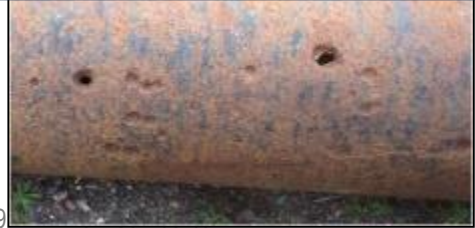
## Scotchkote 2400

**Corrosion barrier**  
Prevent tuberculation and corrosion related pin-hole leaks, and protect clean water

**Structural enhancement**  
Internal pressure containment that will withstand the formation of 2 in (5 cm) corrosion holes

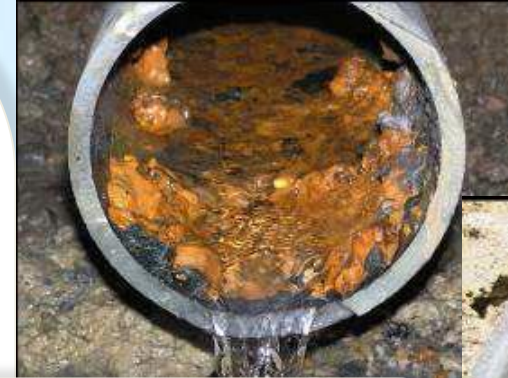
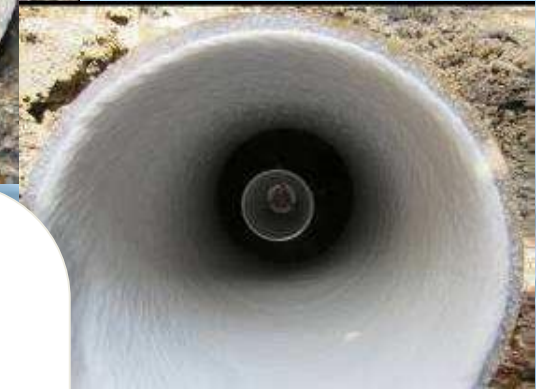
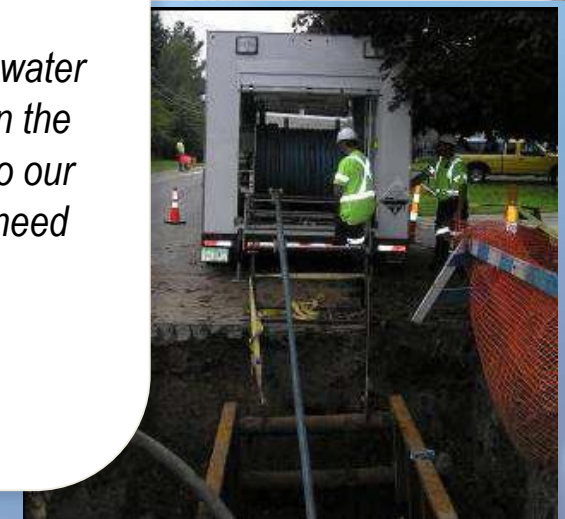
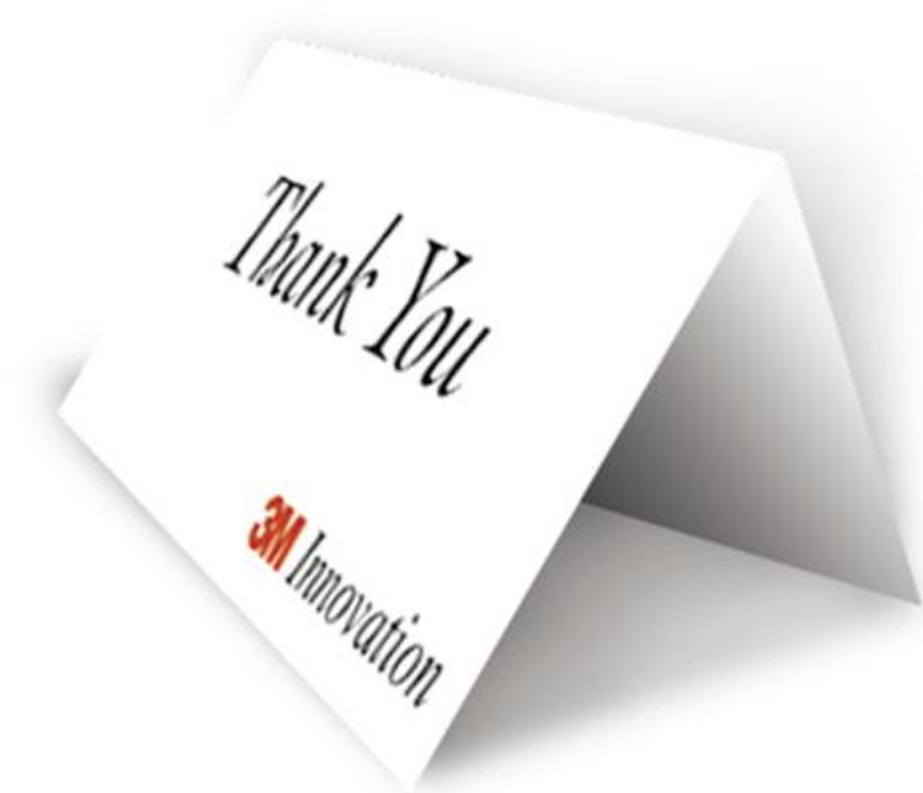
## Oswego Water Department, Oswego, NY

- Severe water discoloration due to tuberculation
- Three emergency repairs/splices in two years
- Time and budget constraints

- Resolved water quality issues
- Improved pipe integrity by spanning pitting, pin holes and gaps
- Returned to service each day by 6 p.m., with boil notices
- Provided significant cost savings by eliminating the use of bypass pipes
- Project was 5 days, 350 – 490 ft/day

- Six inch (150 mm) cast iron pipe, installed in 1923
- Length: 2,265 feet (690 m)
